**NISTIR 5488**

# **Performance of HUD-Affiliated Properties During the January 17, 1994 Northridge Earthquake**

August 1994  
Building and Fire Research Laboratory  
National Institute of Standards and Technology  
Gaithersburg, MD 20899

*Prepared for:*  
U.S. Department of  
Housing and Urban  
Development

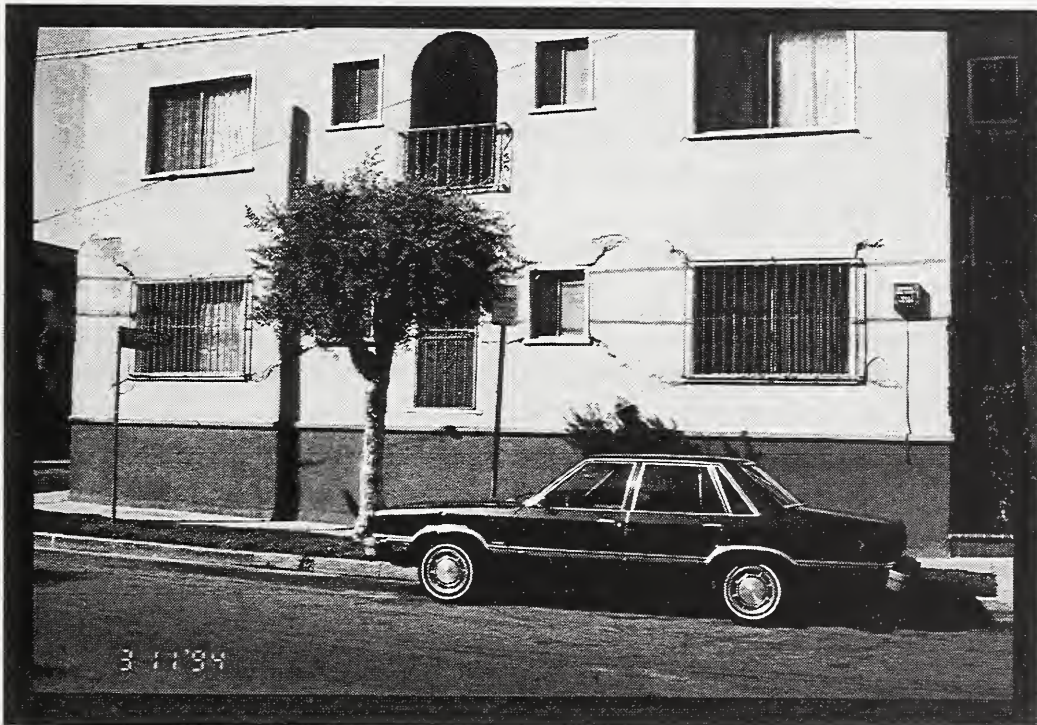
*Figure 1      Residential construction is characterized by multiple door and window openings. The corners of these rectilinear openings create stress concentrations, making these locations particularly vulnerable to cracking.*

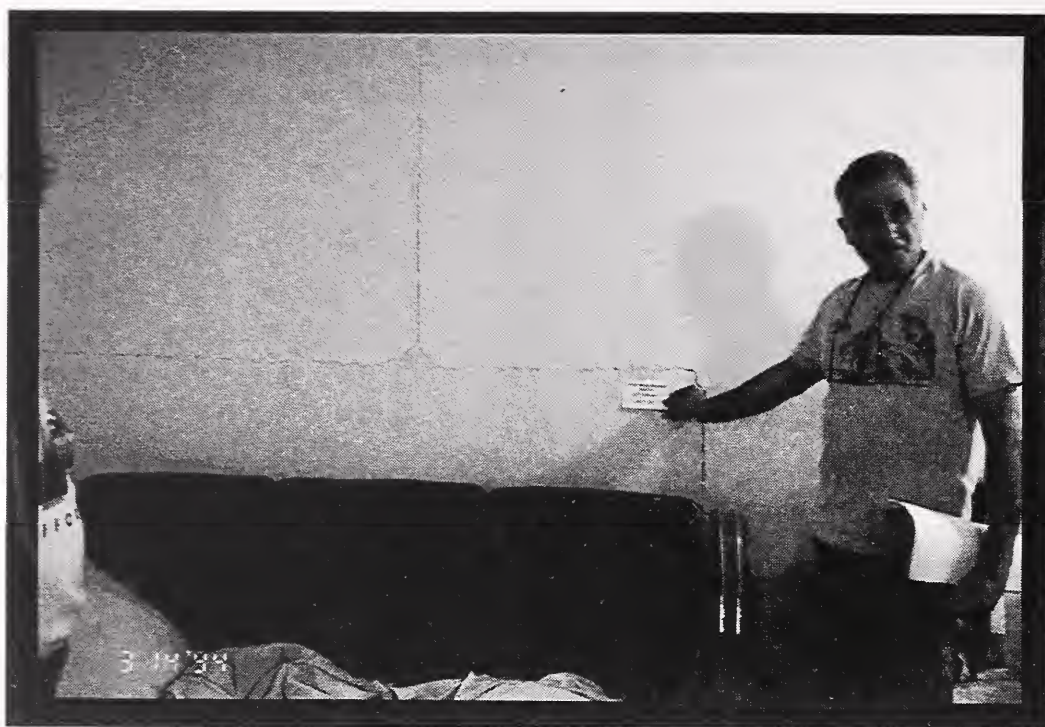
*Figure 2 Typical nonstructural damage caused by the Northridge earthquake in residential buildings included cracks in interior partition walls, such as these horizontal and vertical cracks at the edges of the gypsum wallboard panels.*

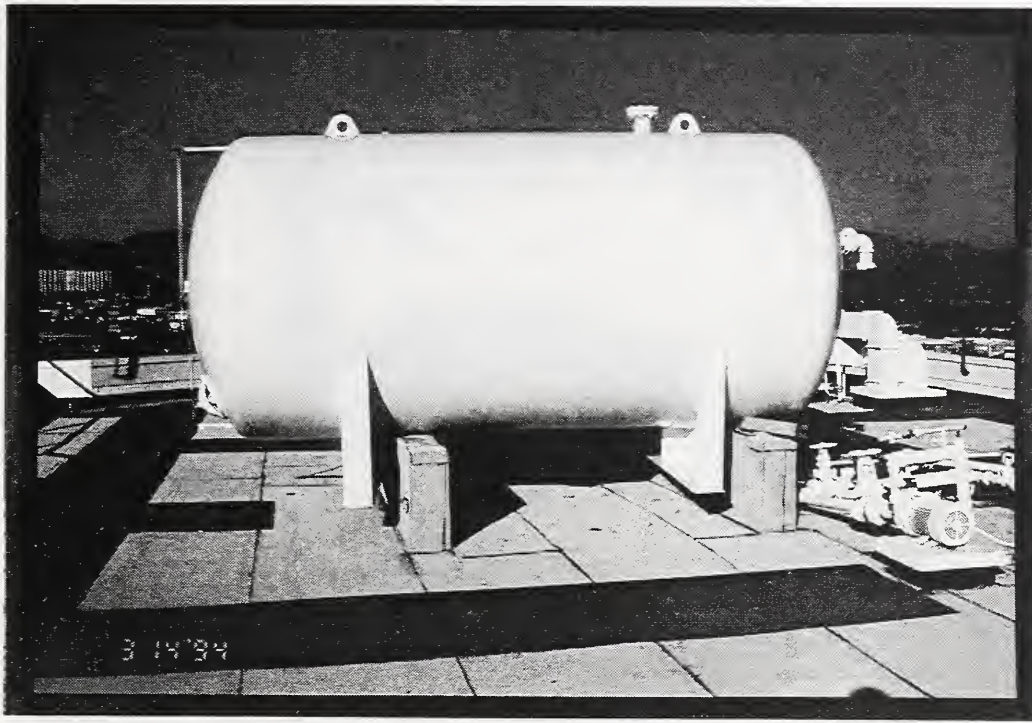
*Figure 3      Movement of equipment, such as this 130,000 liter rooftop water tank at Fickett Towers, caused collateral damage in some cases. When this tank dropped from its supports, rupturing a water pipe, water damage to the building interior resulted.*

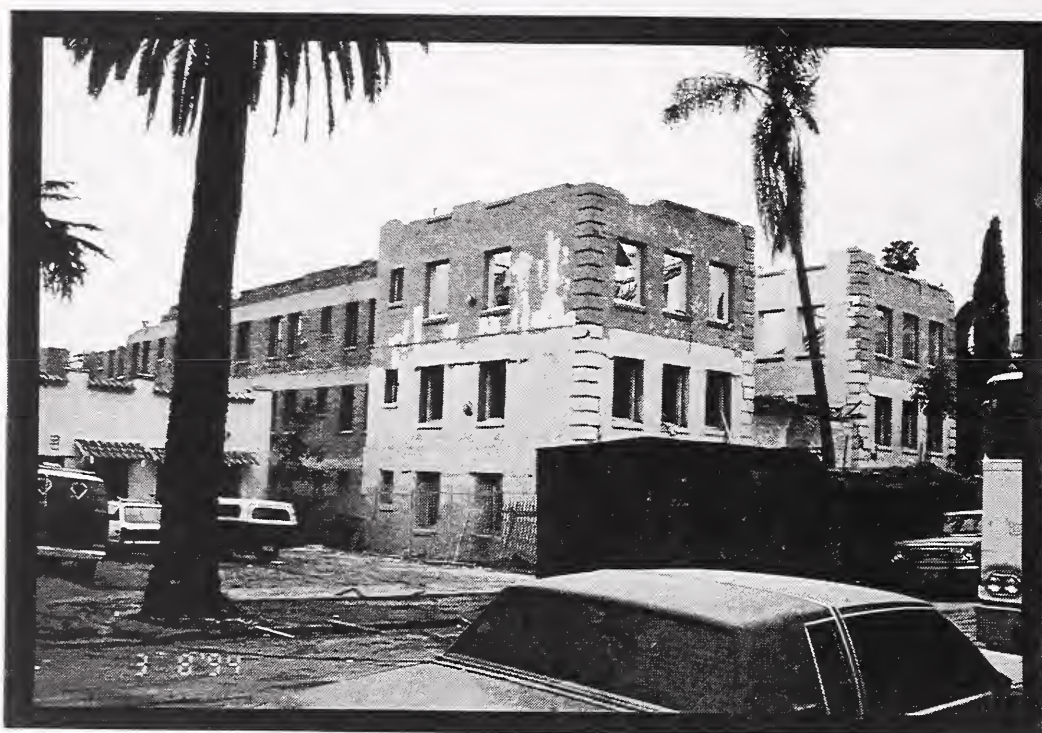
*Figure 4*      *Vadehra IV, an unreinforced masonry building, was condemned because of extensive earthquake damage. When this photograph was taken, the top story had already been removed by the demolition team.*

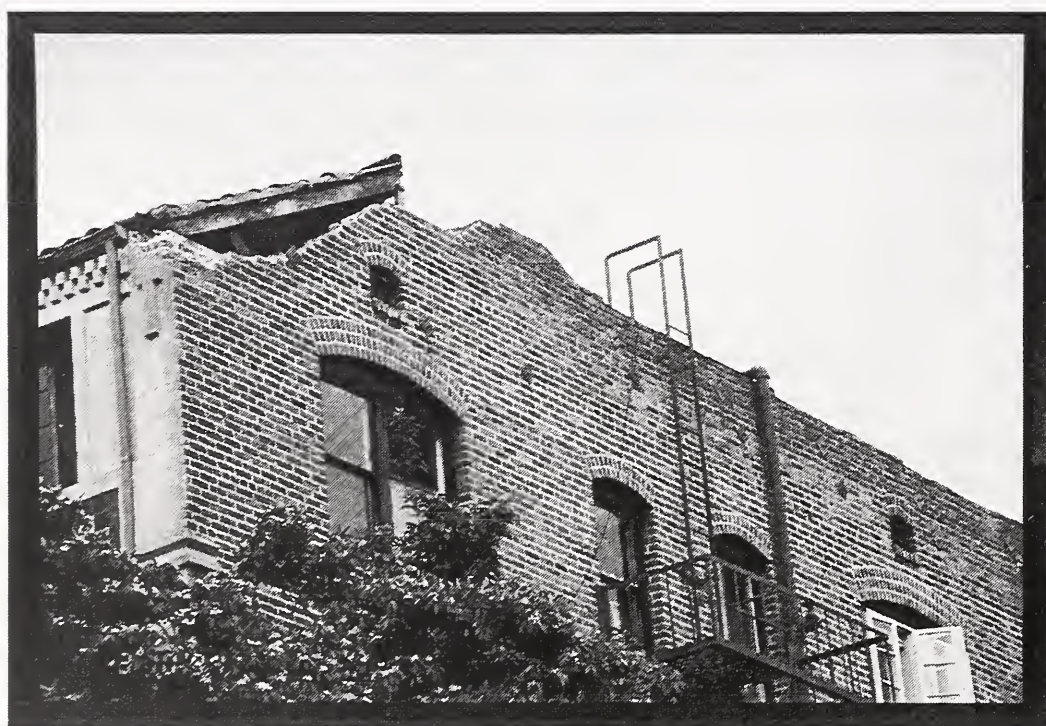
*Figure 5*      *Loss of portions of the parapet and wall at Uptown Manor, an unreinforced masonry building, caused several living units to be declared unsafe by city inspectors.*

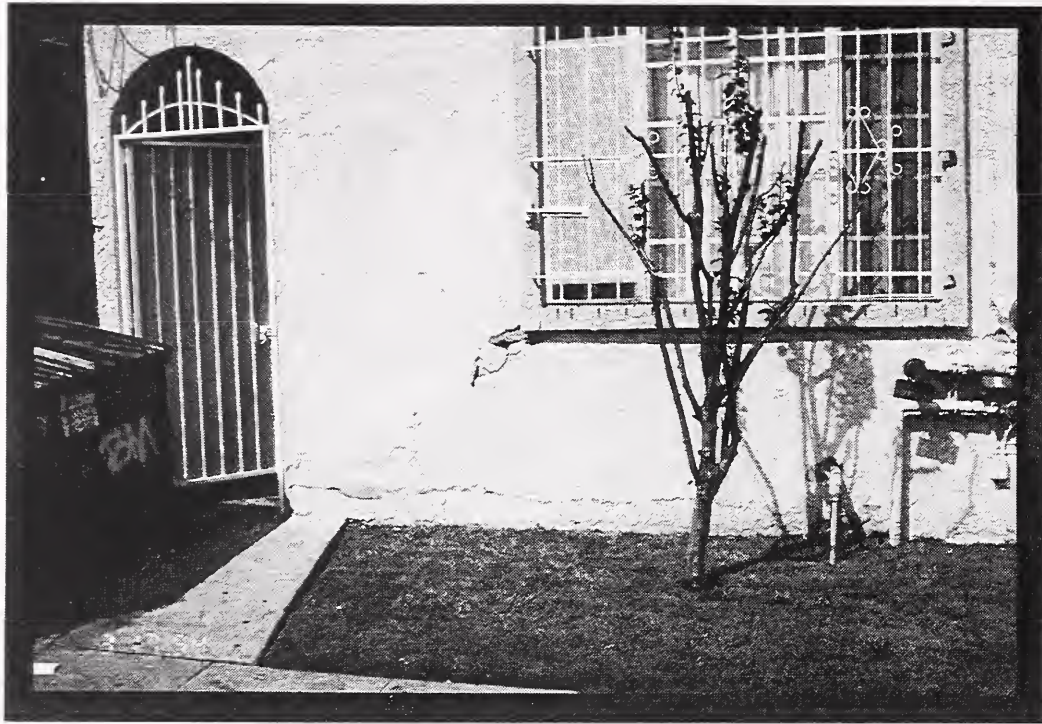
*Figure 6*      *Sunset Apartments E, a three-story wood-frame apartment building, was declared by city inspectors to be potentially unsafe pending more detailed evaluation (yellow tagged). Note the horizontal crack in the stucco at the foundation line, the vertical crack to the right of the window, and the diagonal crack and buckled area of stucco at the lower corner of the window.*

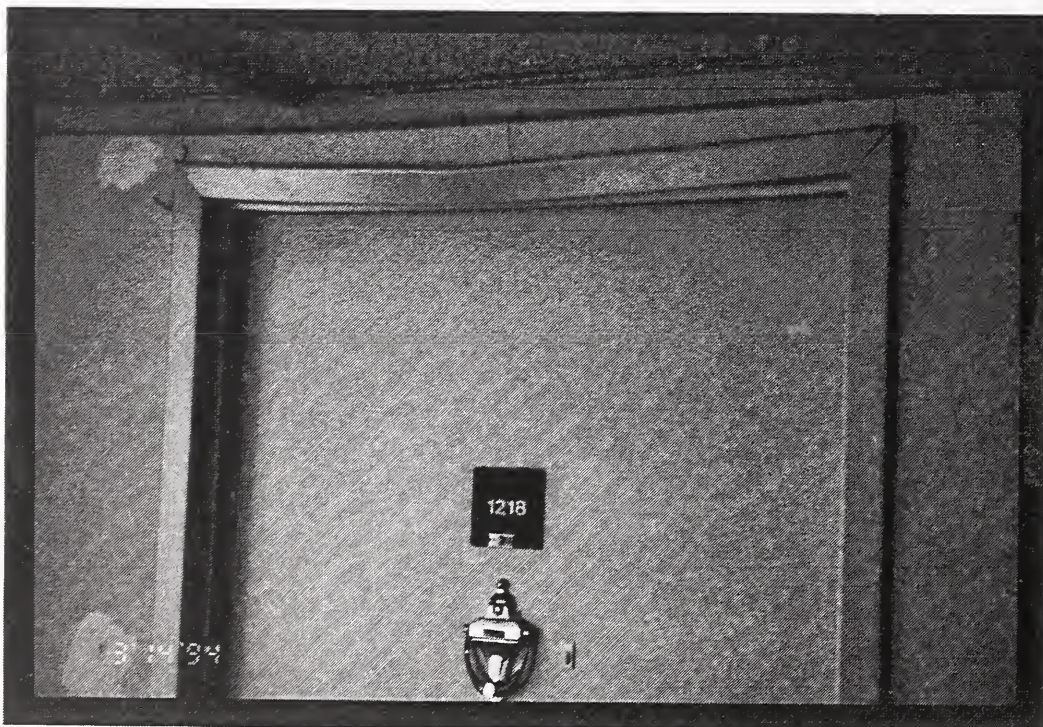
*Figure 7*      *Buckled door frames occurred in several buildings.*

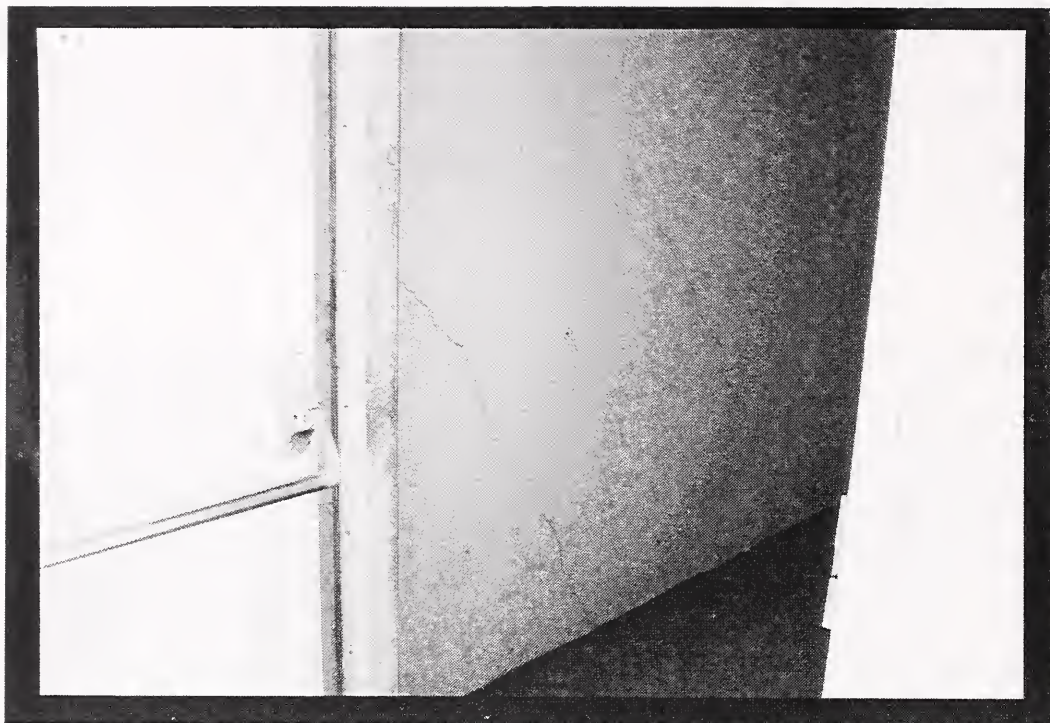
*Figure 12 Structural damage in concrete buildings included diagonal cracks in shear walls, such as these in Beverly Towers.*

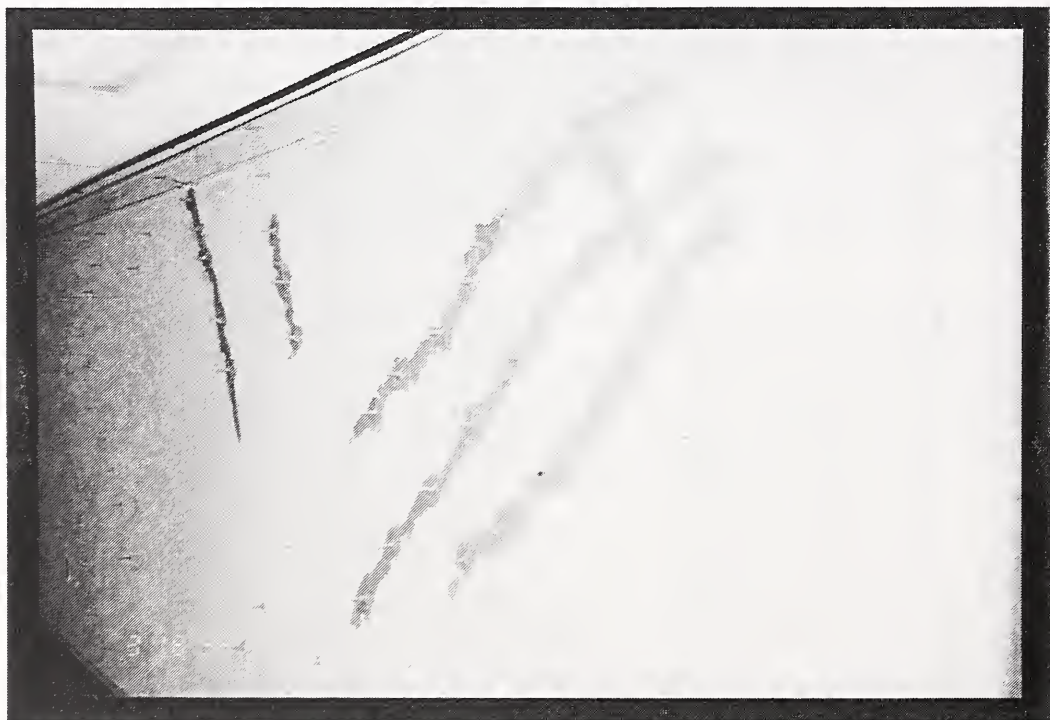
*Figure 13 Some of the diagonal cracks in concrete shear walls were already under repair at the time of this study. At Santa Monica Christian apartments, cracks were being repaired using an epoxy injection technique.*

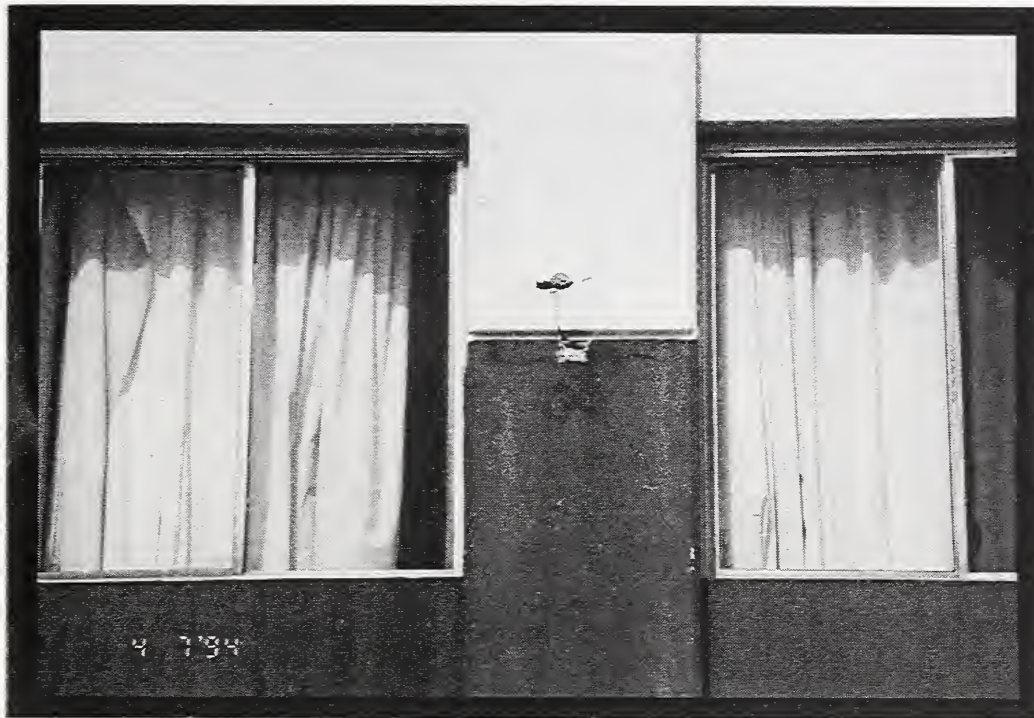
*Figure 14 In concrete frame buildings, such as Westminster Towers, diagonal cracks in concrete columns were observed.*

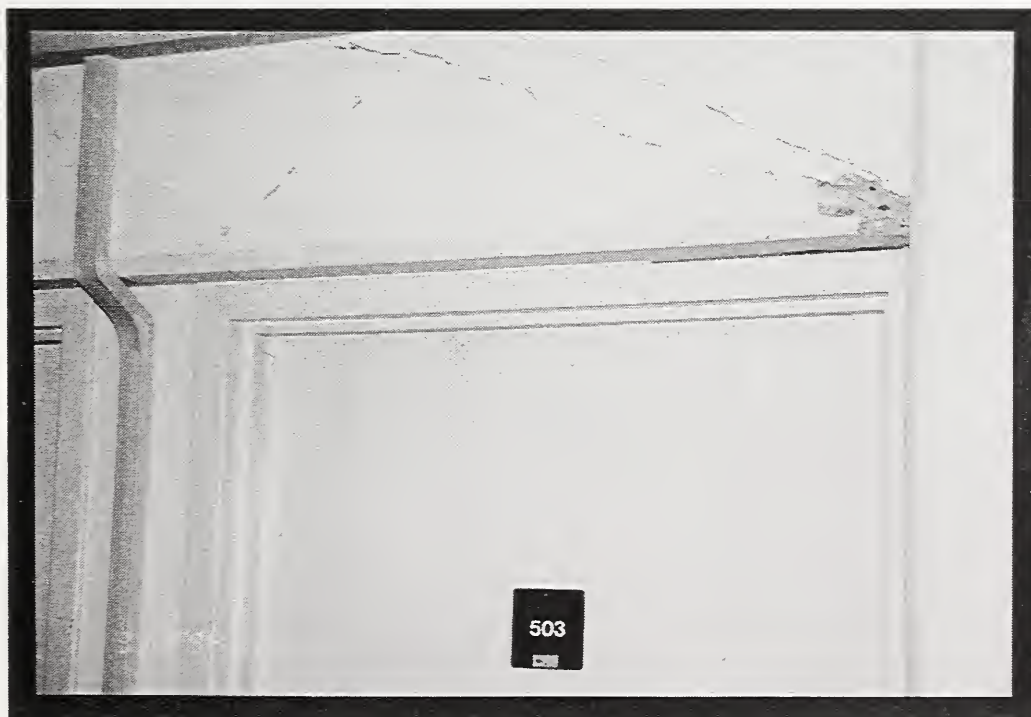
*Figure 15 Diagonal cracks between openings in shear walls, such as these above a doorway at Fickett Tower, are examples of commonly observed earthquake damage in concrete shear wall buildings.*

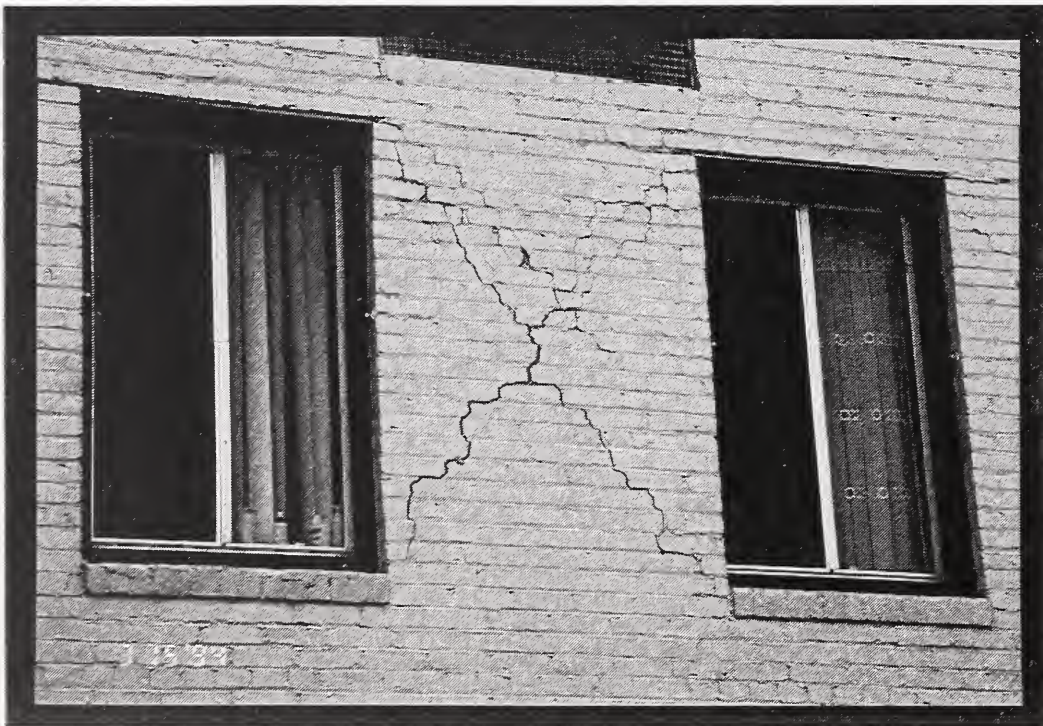
*Figure 17 The masonry facade between windows at the Hollywood Knickerbocker, a 63-year old concrete frame building, displayed earthquake-induced X-cracking.*

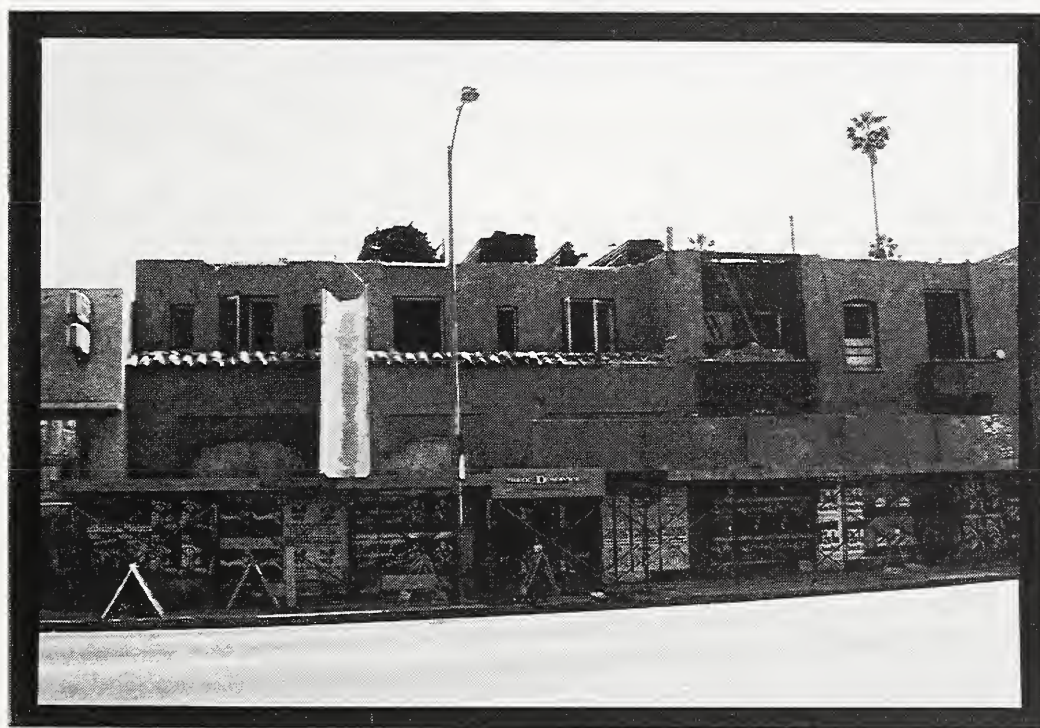
*Figure 19 Vadehra Vb, an unreinforced masonry building, was already under demolition at the time of this study. The top floor of this four story building had already been removed at the time this photograph was taken.*

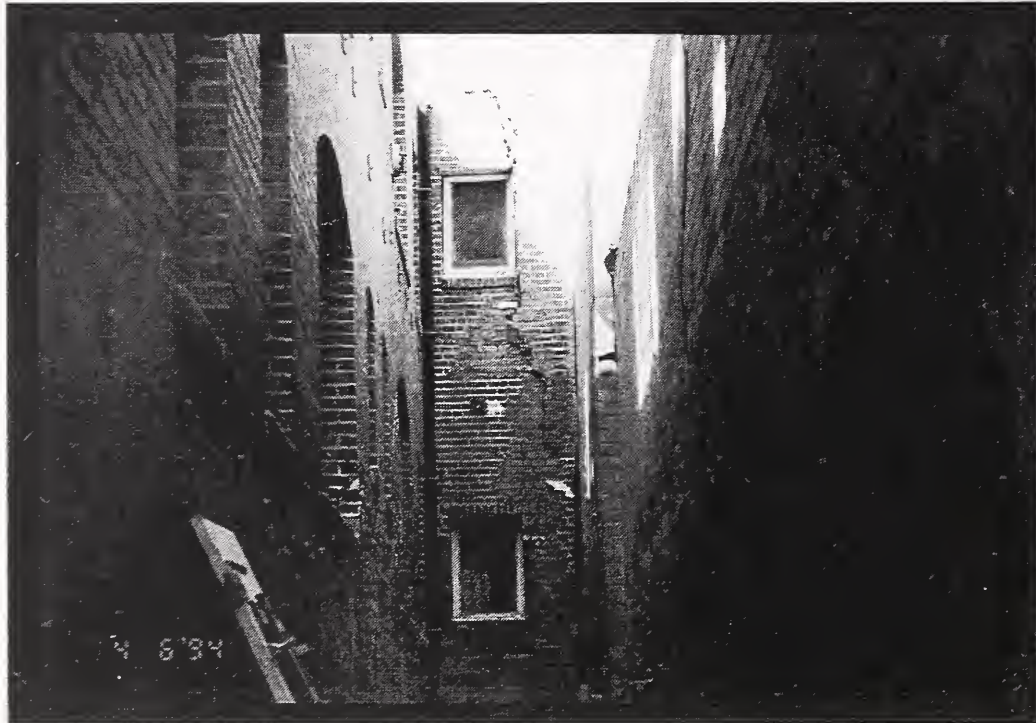
*Figure 20 This view of an the inside corner of the T-shaped Vadehra Vb building shows substantial vertical cracks and movement of portions of the wall. Note that this building, which had been condemned and was under demolition, had been rehabilitated before the earthquake with through-bolts.*

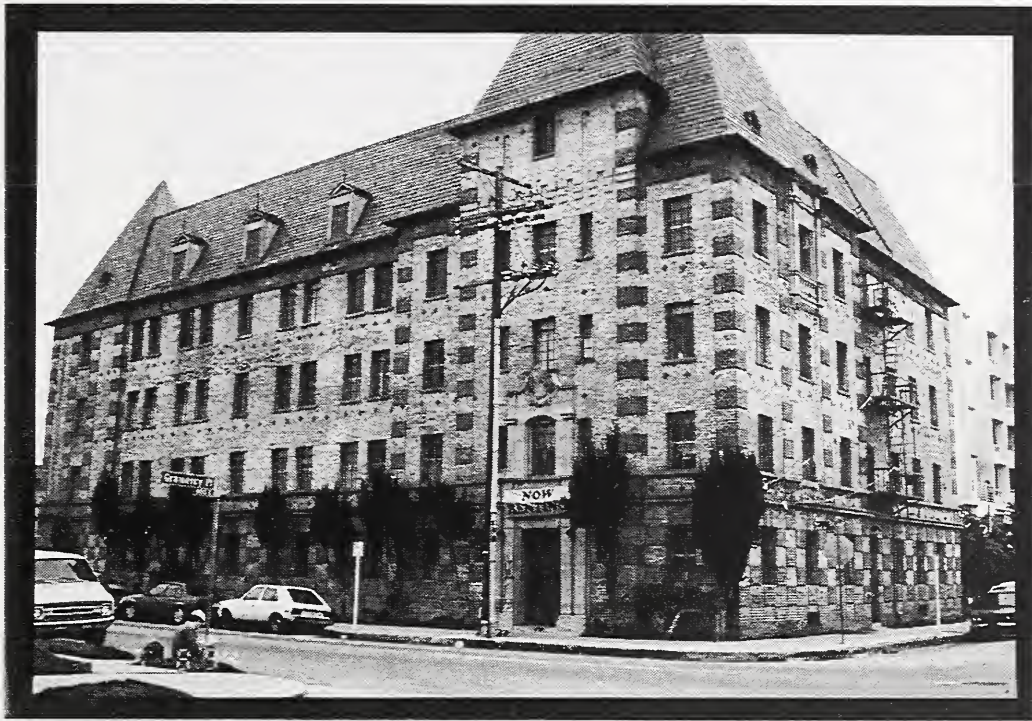
*Figure 21 Villa Park Merridy, an unreinforced masonry building that had been rehabilitated prior to the Northridge earthquake, suffered no structural damage and only minor nonstructural damage.*

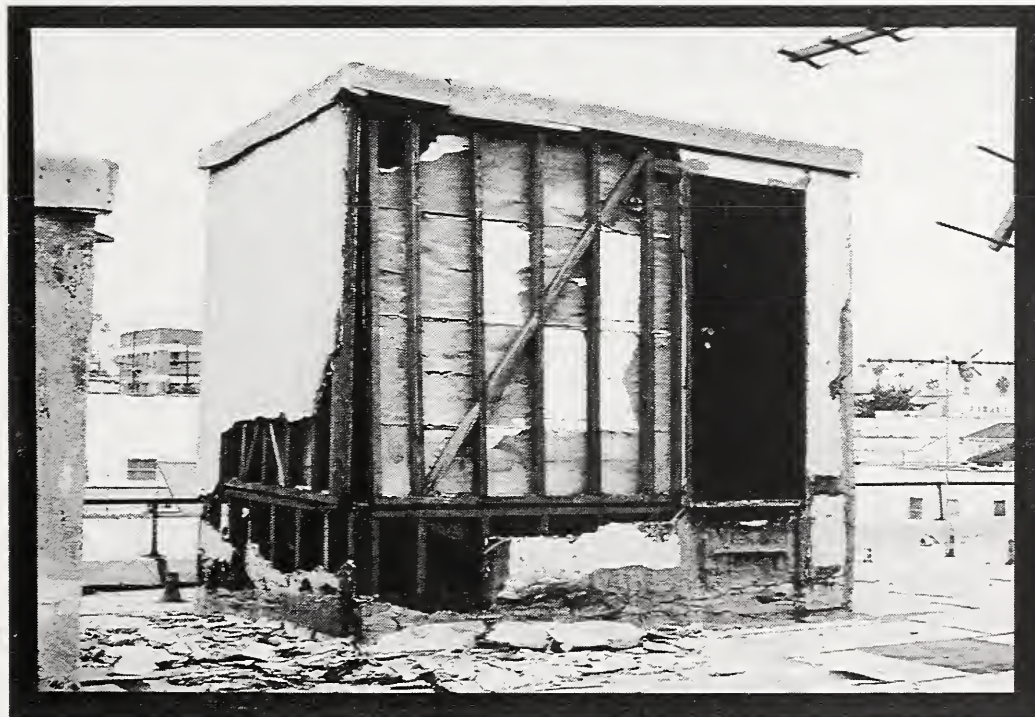
*Figure 22 The wood-framed, stucco-clad elevator penthouse on the roof of the 3-story Vadehra IIIb building experienced extensive damage to the stucco, but the operation of the elevator was not affected.*

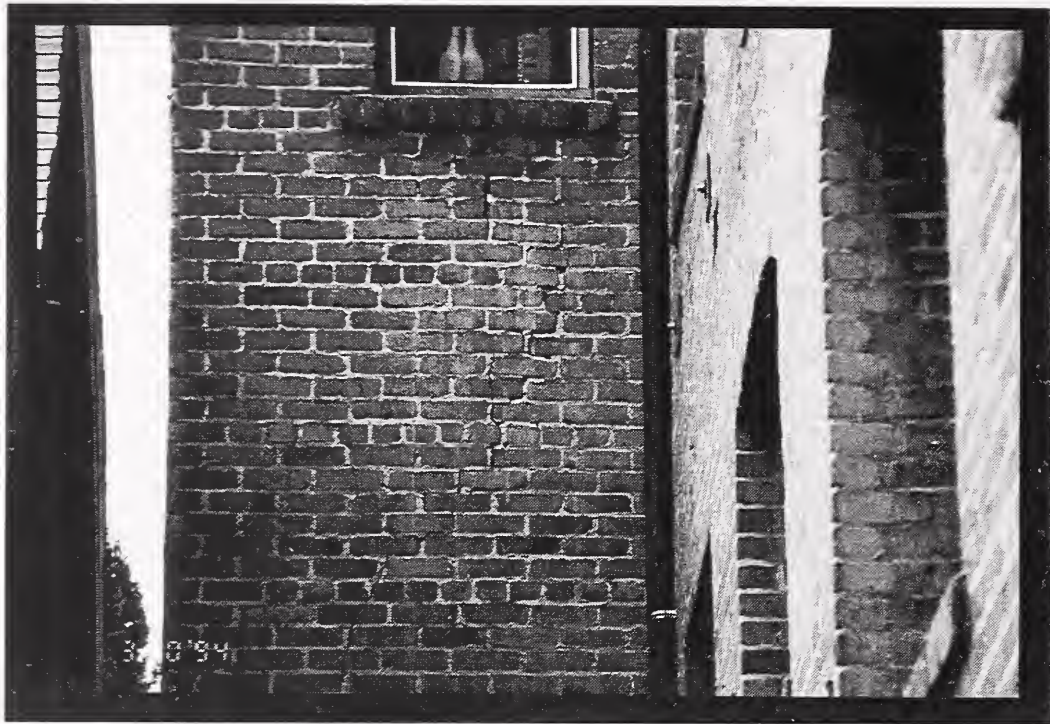
*Figure 23 Vadehra IVb, a T-shaped unreinforced masonry building, suffered cracks in the short walls at the inside corner of the T that in some locations followed the line of the mortar and in other locations cracked brick units.*

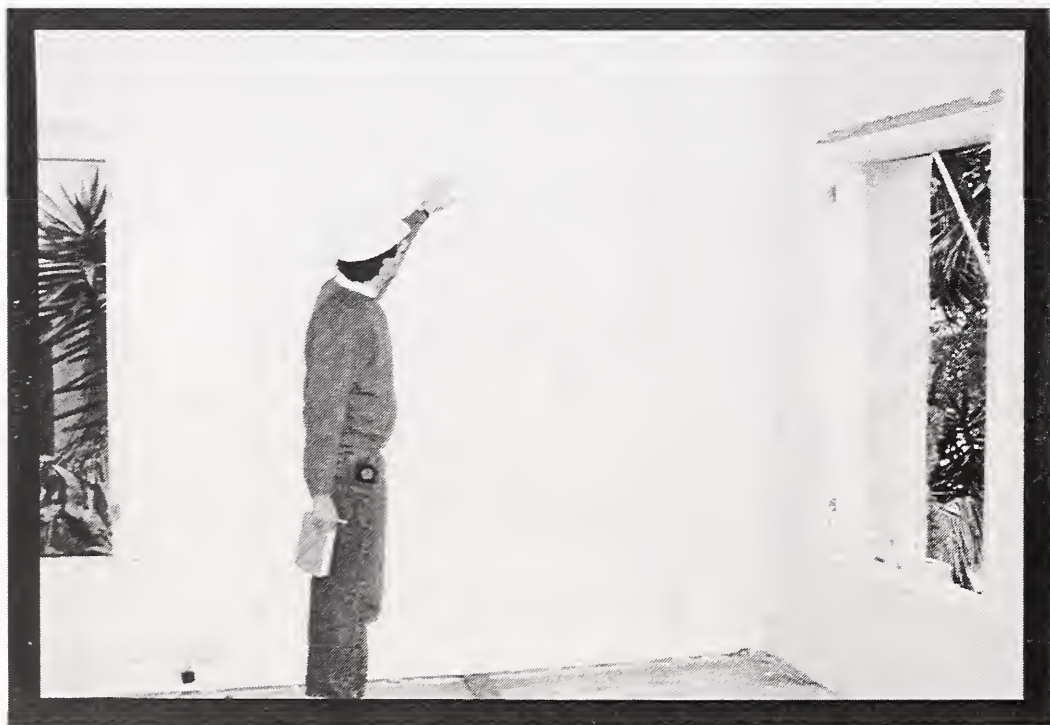
*Figure 24 Damage observed in unreinforced masonry buildings included cracks in the interior plaster.*

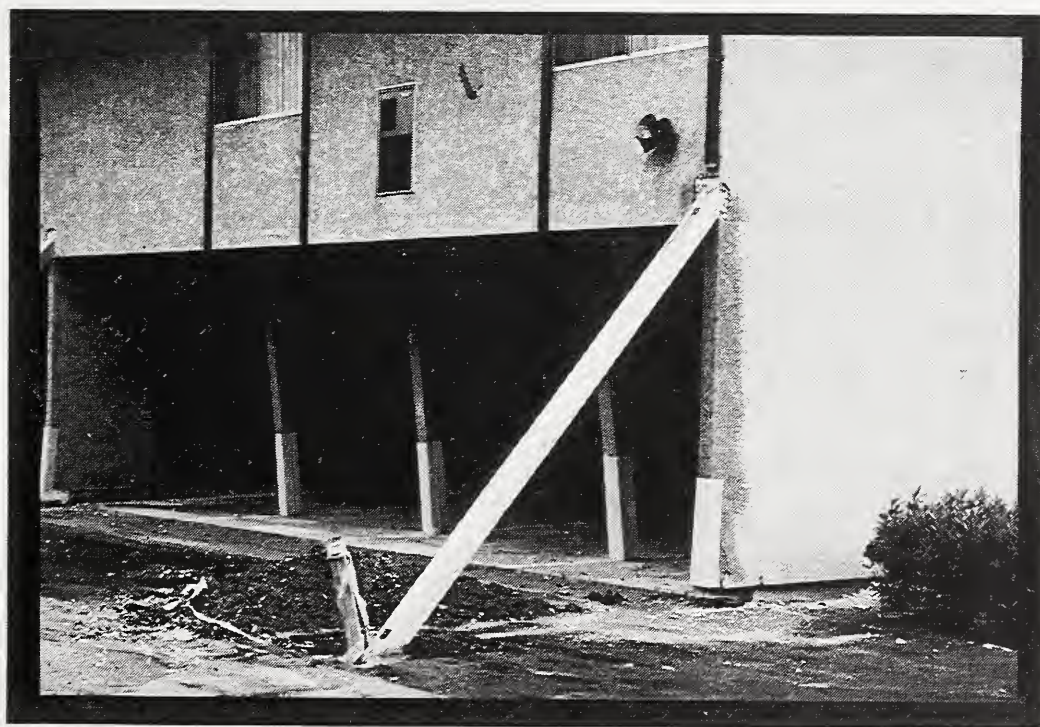
The most spectacular damage occurred at Grenada Gardens, a 51-building complex about 6.5 km from the epicenter: 120 out of 169 units were vacated. Those buildings with the first story open for parking underwent large displacements relative to the foundation, creating permanent offsets (fig. 25). Relative lateral displacements of 0.35-0.45 m were measured. None of the buildings suffered a complete collapse of the first story. The second story apartments in those buildings with first floor parking suffered less nonstructural damage, such as dislodged commodes, cracked gypsum wallboard (fig. 26), and broken glass in sliding doors, than did the apartments in buildings with living units on both levels.

*Figure 25 At Granada Gardens, many of the two-story wood frame buildings that had open first levels for parking experienced significant racking and permanent offsets.*

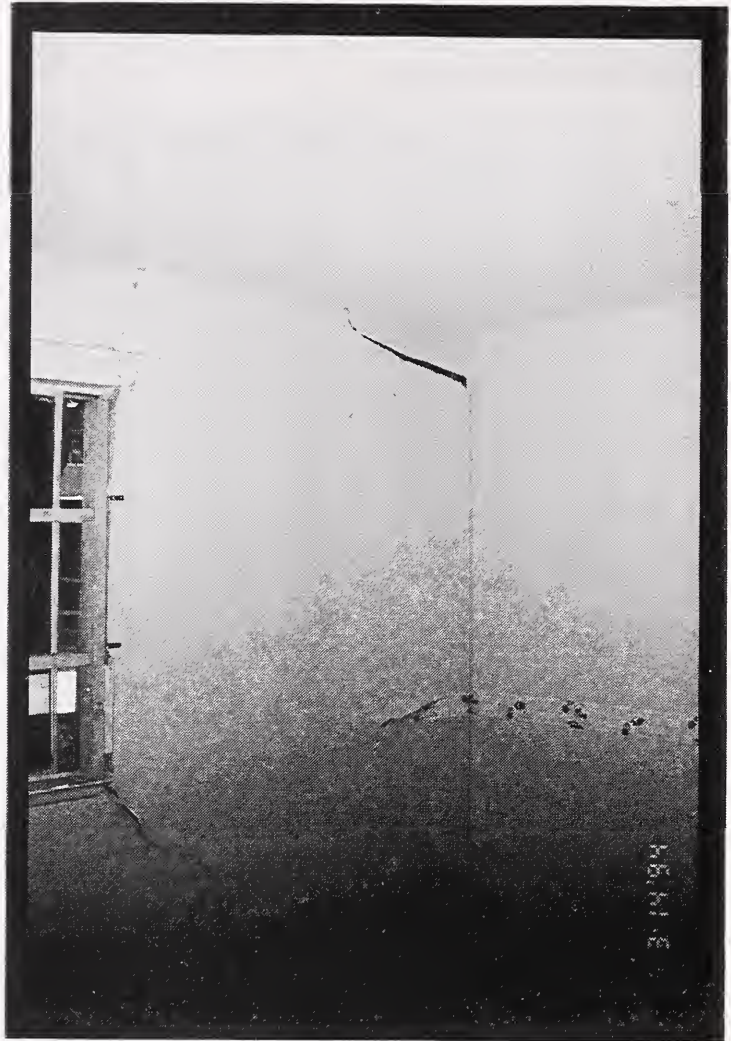
*Figure 26 Interior damage at Granda Gardens included cracks in the gypsum wallboard.*

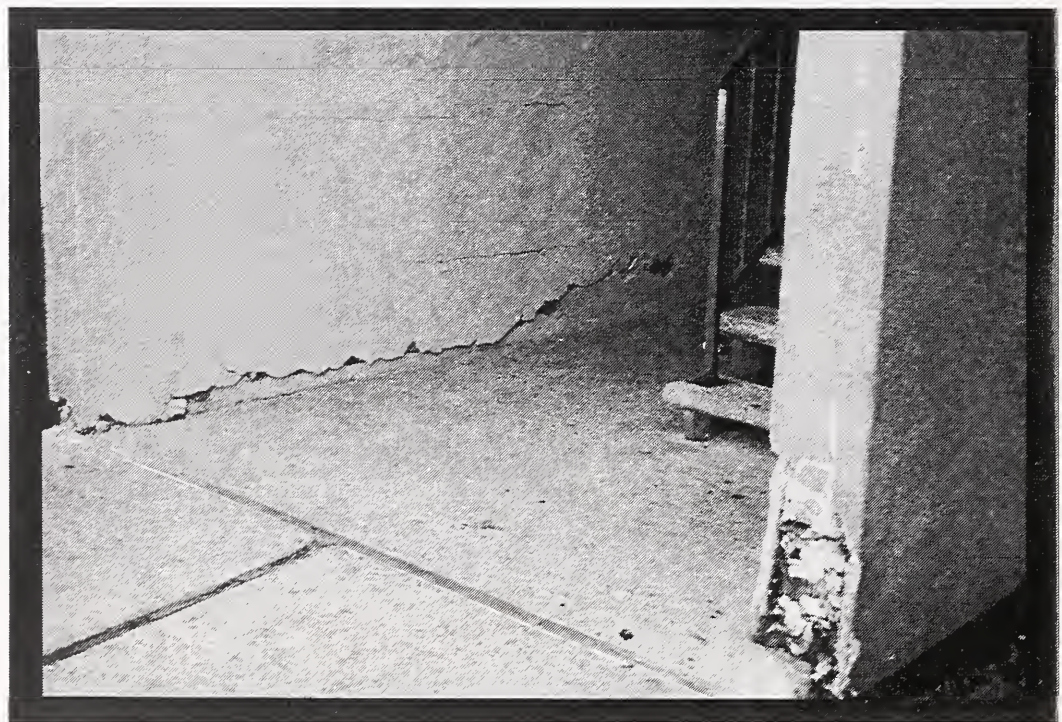
*Figure 27 Horizontal cracks in exterior stucco occurred where the relatively flexible wood frame walls joined the more rigid concrete foundation walls.*
